# Manhole Inspection Summary

Manhole # S35Q\_\_005MH

**Location** Address: **14 e west st**

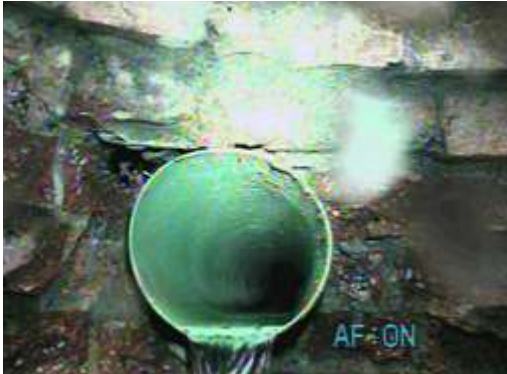
Pipe In at 5 oclock

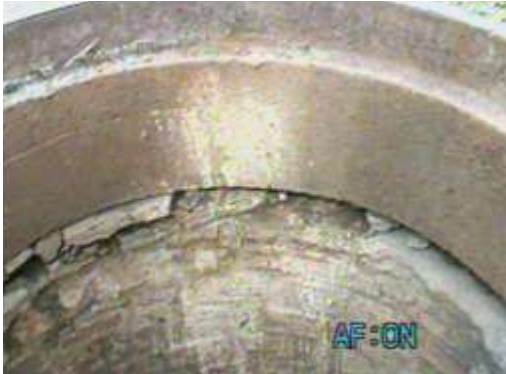
Defect 2

Condition: ☐ Sound ☐ Cracked ☐ Root Intrusion ☒ **Loose Brick** ☒ **Deteriorated**

loose bricks and deteriorated corbel

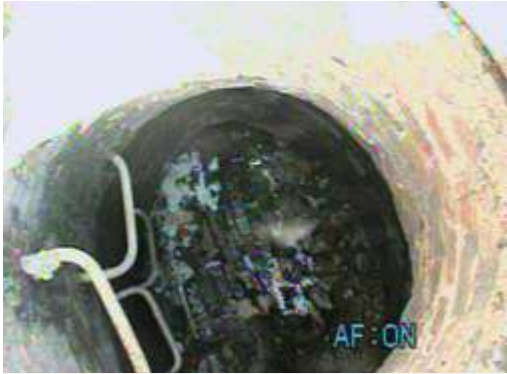
Defect 1

**Steps** Count: **4** Missing: **0** ☒ **Corroded**

steps

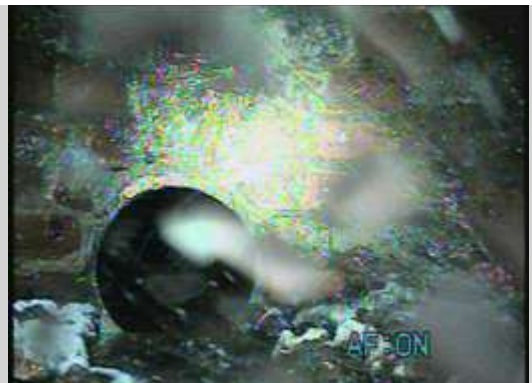
12 O'Clock Outflow

8 in. Circular Gravity Sewer  
Pipe Out @ 12 O'Clock
